### Site 173 Essex County Greenbelt Association Cox Reservation

Great Marsh Coastal Wetlands Restoration Plan  
Rapid Technical Assessment Site 173

## Site 173: Greenbelt Cox Reservation, Essex, MA

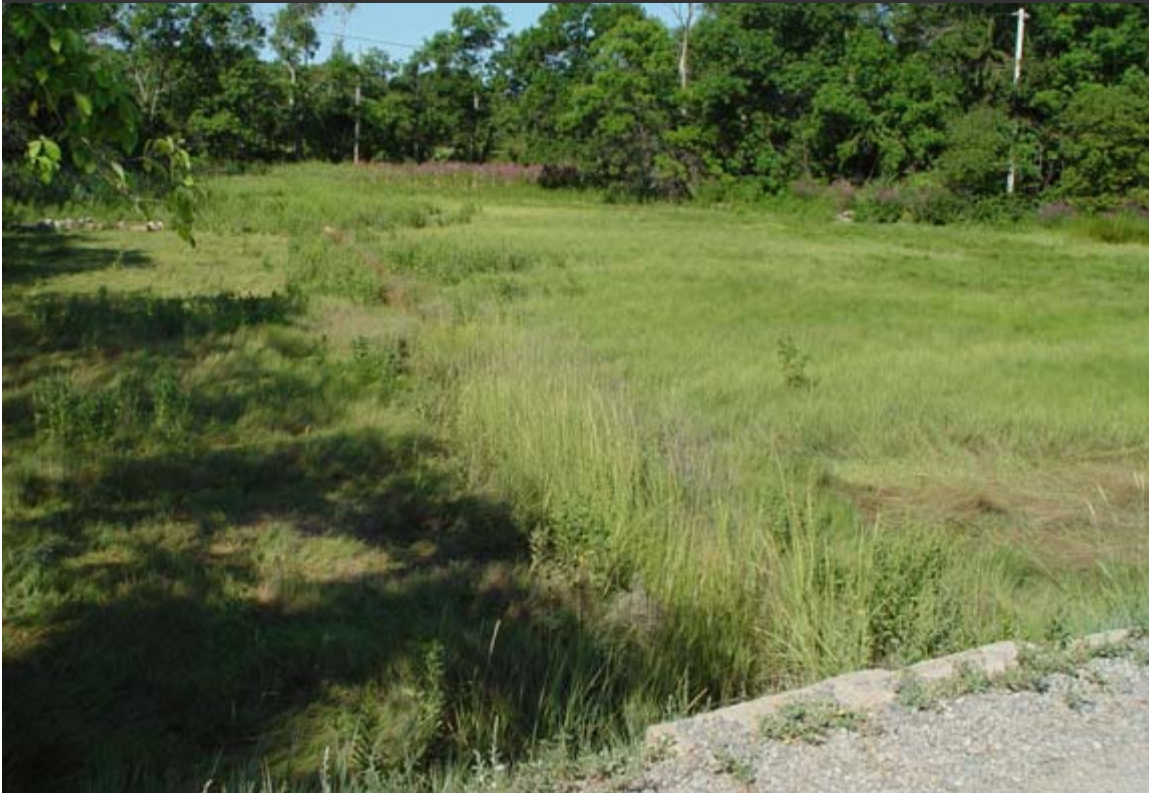
**Photo 1 - Restoration Area Upstream of Driveway Crossing Viewing West**

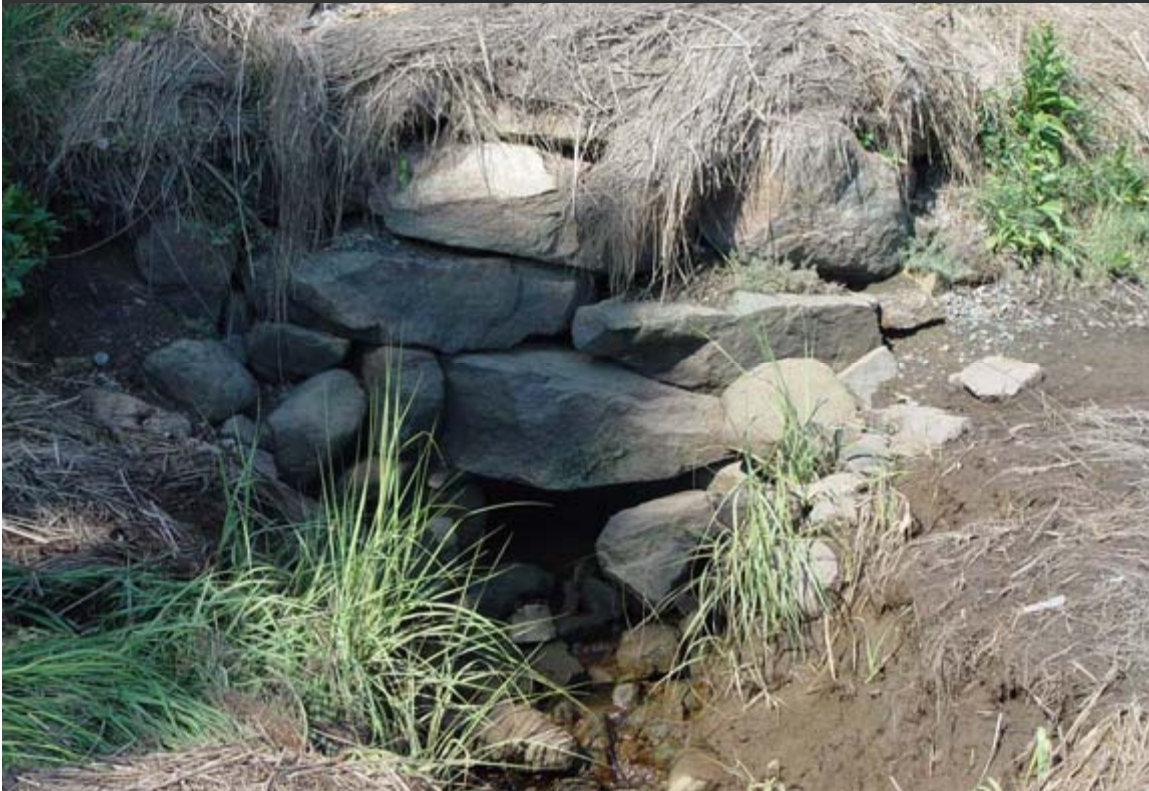
**Structure conditions:** A stone culvert conveys tidal flows from a small creek under the Cox Reservation driveway. The stone culvert is approximately 2.0 ft wide by 1.5 ft high. Cut stones form a retaining wall along either side of the crossing. The gravel driveway is approximately 15 ft wide and is in fair condition. Some road maintenance problems are experienced during wet soil conditions requiring the re-stacking of fallen stones from the headwall and minor regrading. ECGA currently has no plans to improve the crossing. A new sewer connection is planned by tying to a new service line to be installed down the paved driveway. The creek continues upstream and is conveyed under the paved driveway to a private residence via a 12" ductile iron culvert. This crossing appears in good condition. Flow within the creek and overland marsh flow between the two culverts is partially obstructed by the remains of an earlier road crossing. Both culverts are considered to be in fair condition and their life expectancy is estimated to be over 15 years. There is approximately 4.5 feet of cover over the culvert.

**Photo 2 - Downstream End of Driveway Culvert**

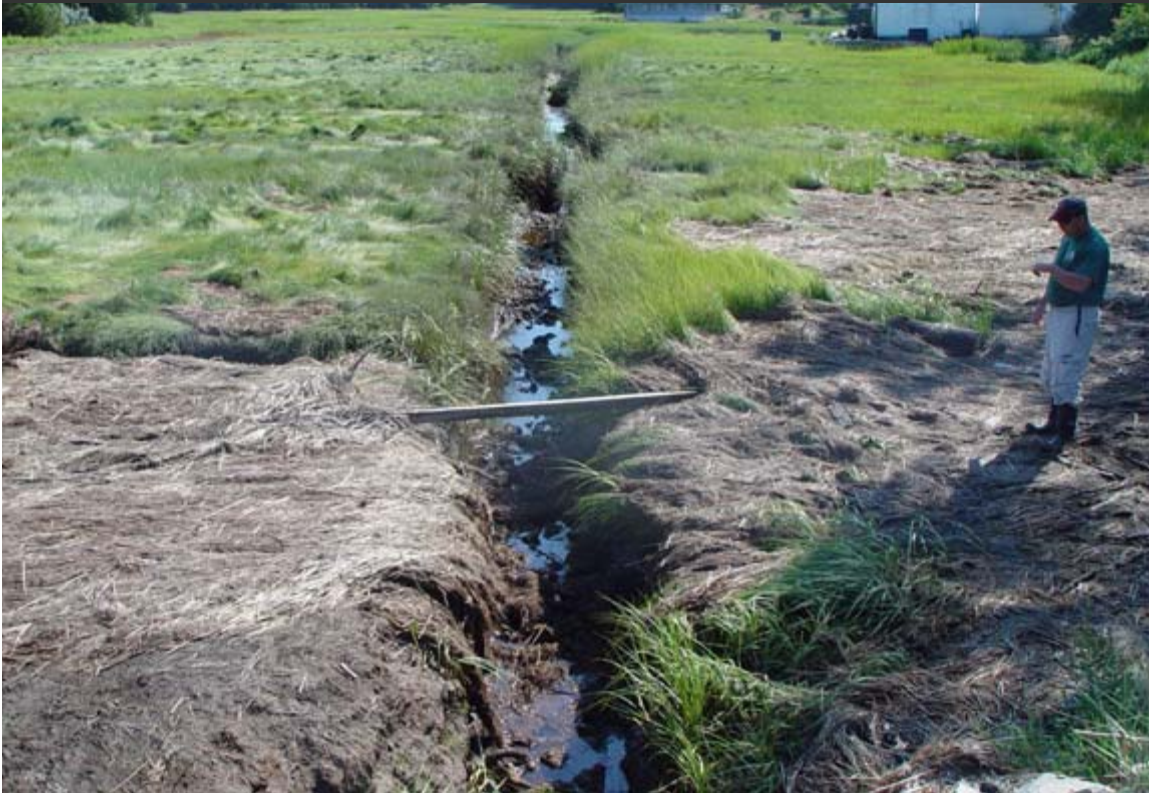
**Photo 3 - Salt Marsh Downstream of Driveway Crossing**

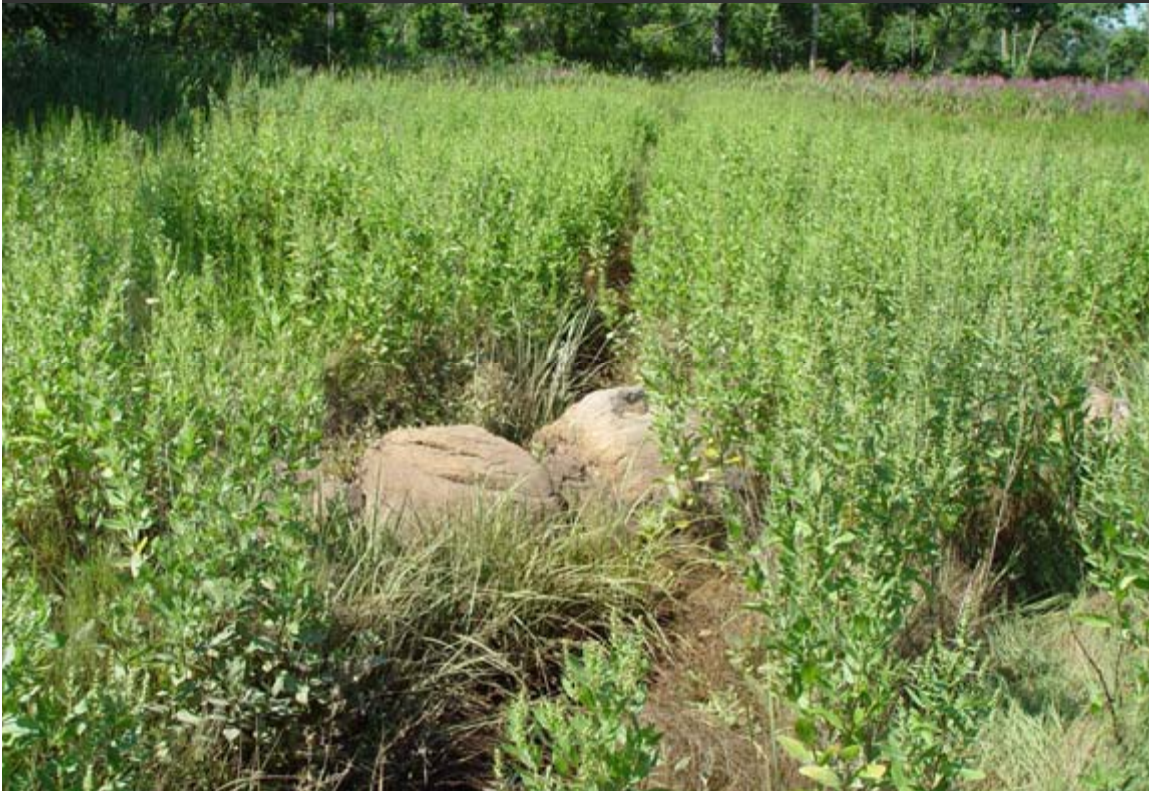
**Photo 4 - Remains of Stone Wall Across Creek**

the restoration effort would have excellent public outreach and education opportunities. Even without the culvert replacement, the removal of the stones obstructing the ditch further upstream from the Cox Reservation, along with improved ditching near the private driveway should be considered. Further studies should focus on the level of interest of the ECGA, the Town and private land owner to undertake the project. The obstruction removal and ditching work could easily be accomplished by the Town.

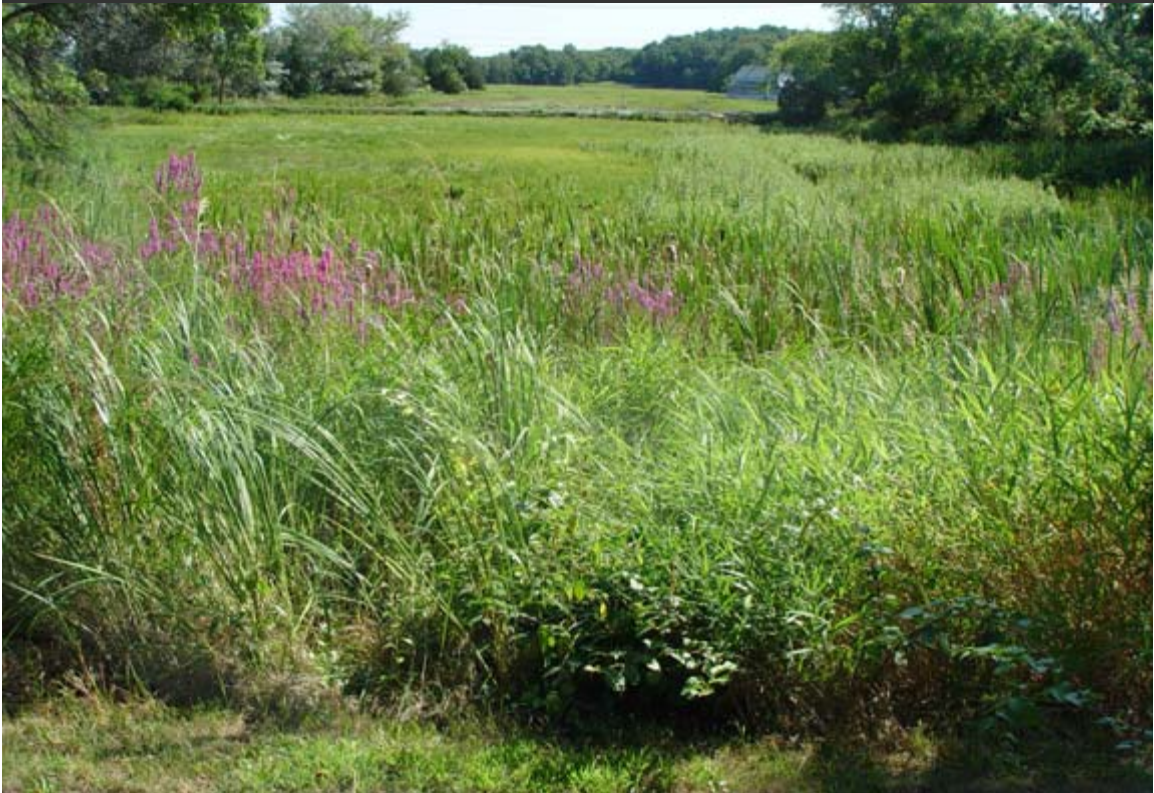
**Photo 5 - Restoration Area Viewed Downstream from Paved Private Drive**

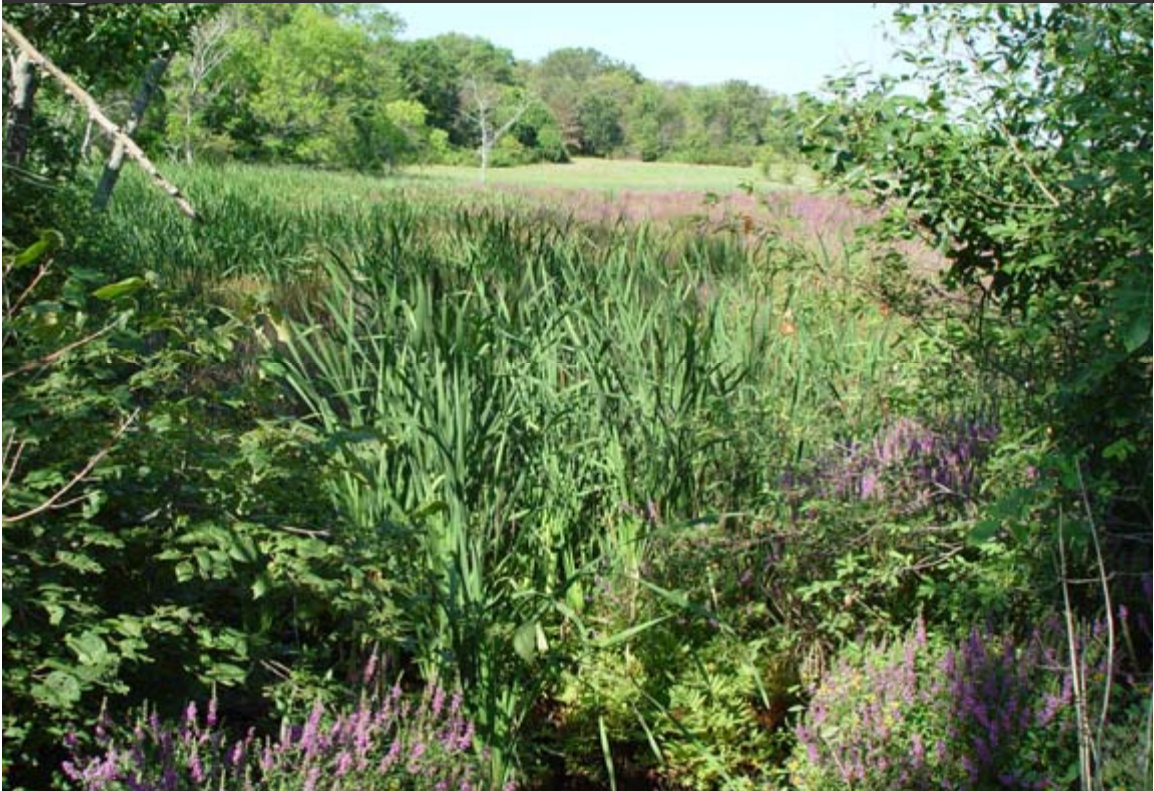
**Photo 6 - Wetlands Upstream of Paved Private Drive**

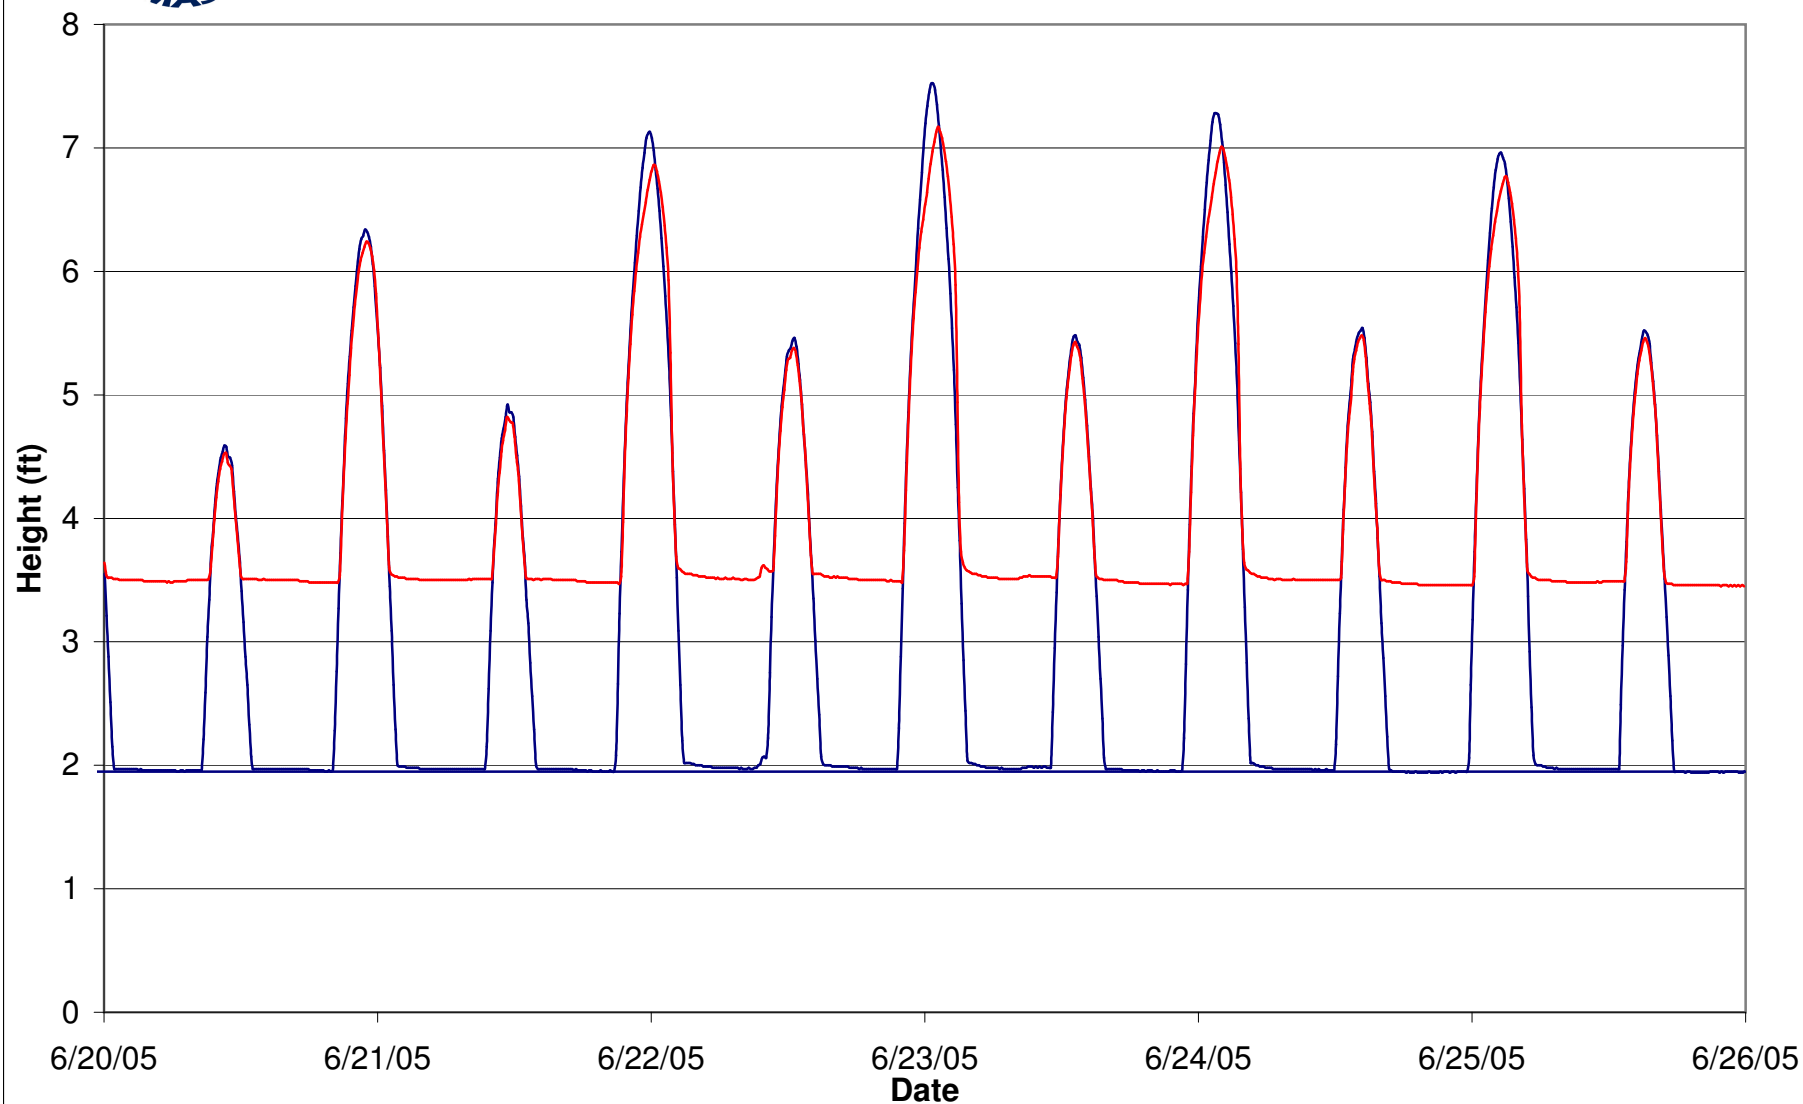
Down Stream  
Up Stream

Two tide gauges were deployed on either side of the Cox Reservation driveway from June 3 to July 8, 2005. Results of the deployment show that the culvert creates a restriction to tidal flow upstream of the road when the height of the high tide downstream of the culvert increases above the elevation of 6 ft (NGVD). Twelve out of 67 tidal cycles recorded during the deployment period reached this elevation downstream of the driveway resulting in less than 0.1ft to 0.35 ft of dampening and delays of less than 10 minutes to 37 minutes. The highest tide recorded at the downstream gauge during the deployment period occurred at 12:34 AM on June 23<sup>rd</sup>. The tide height downstream of the culvert was 7.52 ft NGVD. The tide height upstream of the culvert was 7.17 ft and occurred at 1:11 AM. There was a tidal dampening of 0.35 ft and a delay of 37 minutes due to the tidal constriction at the culvert. The dampening amounted to approximately 6% of the total tidal prism recorded at the downstream gauge. Tides below 6 ft, which are more typical of spring tide conditions, were not substantially reduced by the culvert crossing.
